Technical Service Bulletin

No.LA419-003
11 October 2005

Subject/Concern: Discovery 3/LR3 - Accessory Phone System Fault

Models:
Discovery 3 / LR3

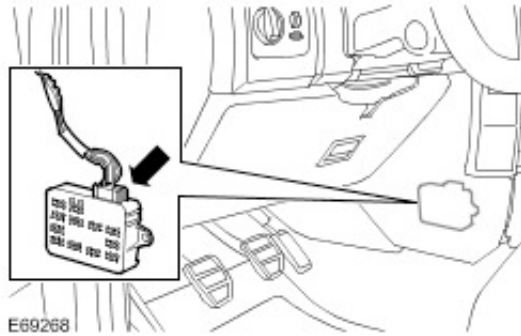
Summary:
A customer may report a concern that when the ignition is switched on or off, the navigation system voice announces 'sorry' or 'command not recognized'.
Cause: This is a component software error from the phone system manufacturer.
Action: On a customer complaint basis only regarding the above, refer to the Service Procedure detailed in this bulletin to renew the telephone module.

1. It will stop the present call being terminated when another call attempts to connect (call waiting).
2. When a call is ended the phone will not stay muted (currently requiring an ignition cycle to rectify the problem).
3. The red button will now cancel an unanswered call.
 - 1 . Release the cellular telephone module from the Velcro® retaining strips.

- 2 . Remove the cellular telephone module from behind the floor console. Refer to illustration in step 1.
- 3 . Disconnect the cellular telephone module electrical connector. Refer to illustration in step 1.
- 4 . Remove the cellular telephone module.
- 5 . Attach Velcro® strips to the new cellular telephone module.
- 6 . Position the cellular telephone module from behind the floor console.
- 7 . Attach the cellular telephone module to the Velcro® retaining strips.
