REPAIR PROCEDURE

DETERMINE INITIAL HOOD ALIGNMENT AND ADJUST BUFFERS AS NEEDED

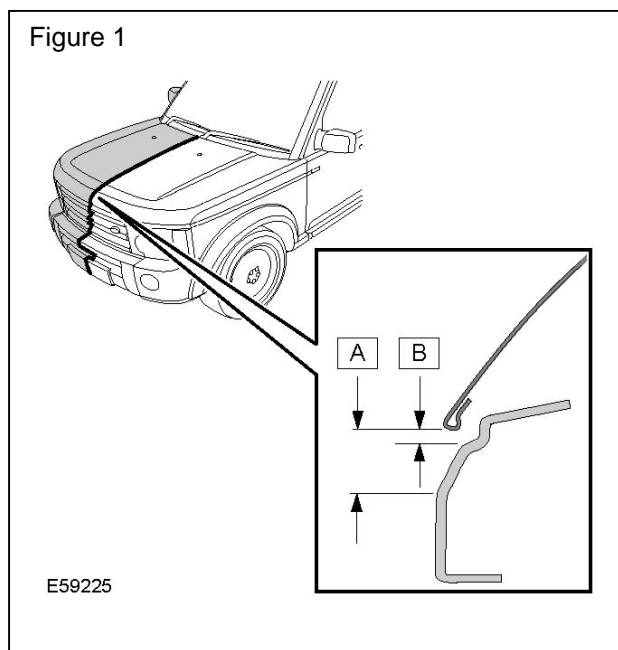
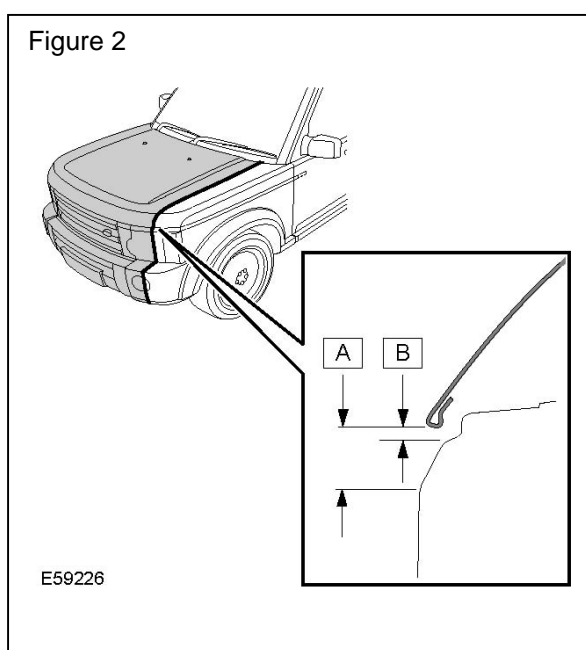
△ NOTE: The following gap definitions are used:

- Gap A is the nominal setting for a closed hood condition, $22\text{mm} \pm 1.4\text{mm}$ ($0.315\text{in} \pm 0.055\text{in}$)
- Gap B (over-slam gap) is the minimum the gap should be reduced to when the hood is being closed, $8\text{mm} \pm 1.4\text{mm}$ ($0.315\text{in} \pm 0.055\text{in}$).
- Gaps are measured at the centerline of the hood and above each headlamp.

△ NOTE: During closure, the hood rubber buffers compress to aid latching. If the rubber buffers are incorrectly adjusted, the over-slam gap may be reduced and could result in the hood contacting the grill.

1. Check for correct gap conditions of $22\text{mm} \pm 1.4\text{mm}$ at the center-line of the hood and at the headlamps.
2. If the correct gap measurement is not obtained adjustment of the hood latches, hood rubber buffers or hinges as outlined in the following procedural sections is required to obtain the correct gap conditions.

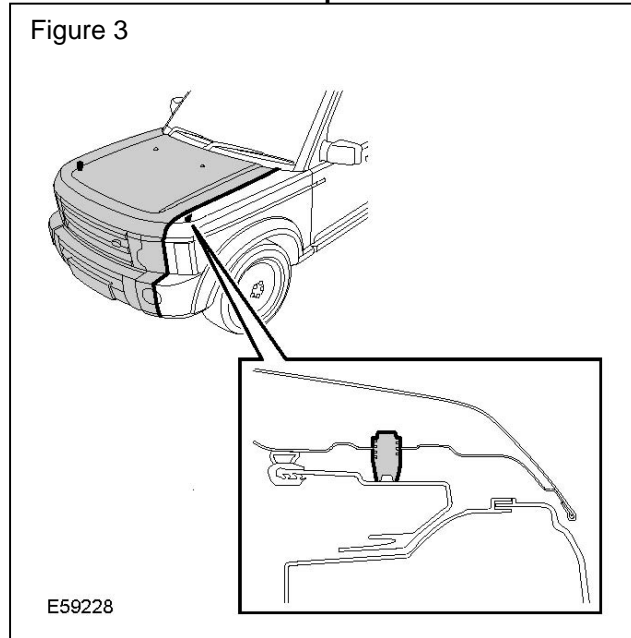
Figure 3

NOTE: Proper hood buffer installation is critical to the proper securing of the hood assembly.

- If the rubber buffers have insufficient contact, hood movement could occur while driving.
- If the rubber buffers are protruding too far, difficulty in latching the hood may occur.

3. If the vehicle is before VIN 5A301030, install the correct style buffers (CJM50001).
4. Verify that the hood Gaps A between the hood and grill/headlamps are $22\text{mm} \pm 1.4\text{mm}$.
5. If the correct gap condition is measured, verify that the rubber buffers are in contact with the slam panel. (Figure 3)

6. Determine if the hood rubber buffers are over-extended.
7. Adjust buffers as required to obtain the correct contact.

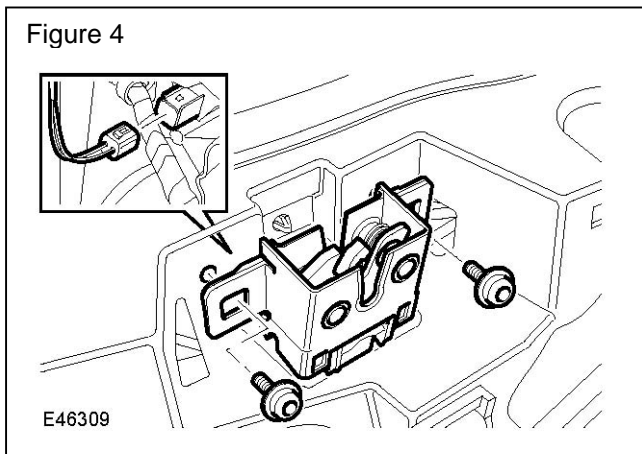
Figure 4

NOTE: The hood switch is integrated into the right-hand hood latch. Minor adjustments to the right-hand hood latch can rectify 'Hood Open' warning messages displayed on the message center.

8. If necessary, adjust the hood latches as follows:
 - Loosen the two hood latch Torx bolts. (Figure 4)
 - Reposition the latch.
 - Lower the hood and check for alignment.
 - Open the hood and tighten the Torx bolts to **10Nm (7lb.ft)**.
 - Check for the correct operation of the hood safety catch.
9. Repeat step 8 as required to obtain the required hood close gap.

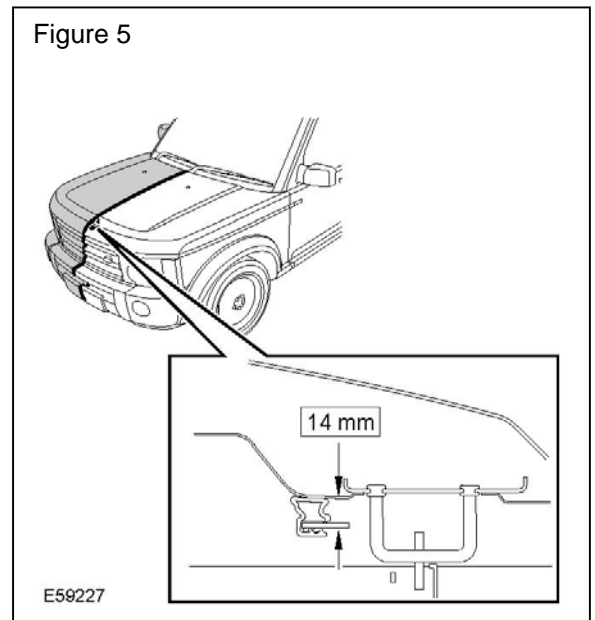
Figure 5

NOTE: Poor sealing at the hood seal to slam-panel will allow air to flow under the hood, causing hood movement. The design gap between the seal carrier and the hood inner edge is 14mm (0.551in).

11. Verify the correct closed gap to compress the hood seal to 14mm gap as follows:

- Create a 20 mm ball of body caulk, putty or other suitably compliant material.
- Position the 20 mm ball on the centerline of the hood in front of the hood seal as indicated by the "14mm" measurement arrows. (Figure 5)
- Gently close and latch the hood, then re-open.
- Verify that in the closed condition the body caulk has been compressed to the 14 mm specified height.
- Adjust as required and retest.
- Remove all measurement material.
