# TECHNICAL BULLETIN

No: LA-501-005

## Visibility from Side Mirror

Land Rover LR3 (LA)

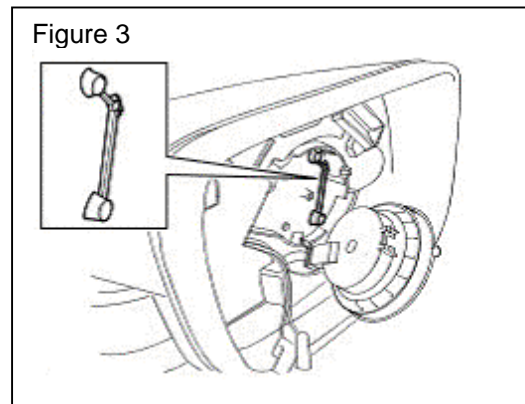
Figure 3

△ **NOTE: The plastic spacer is designed so that each of the end caps fits over a corresponding boss protruding from the main casting and the central tab of the spacer fits into an existing hole in the casting.**

5. Install the plastic spacer onto the main casting. (Figure 3)
6. Position the motor under the inboard clip on the main casting. (① in Figure 4)
7. Push the motor into position. (② in Figure 4)
8. Install the Torx retaining screw and tighten to a maximum torque of **1.2Nm (10.6 lbf.in)**.
9. Refer to GTR Workshop Manual Section 501-09, and install the passenger side door mirror glass.
