TECHNICAL BULLETIN

No: LA-501-016
Issue: 1
Date: 14 Mar 2006

Tailgate Support Mounting

Land Rover LR3 (LA)

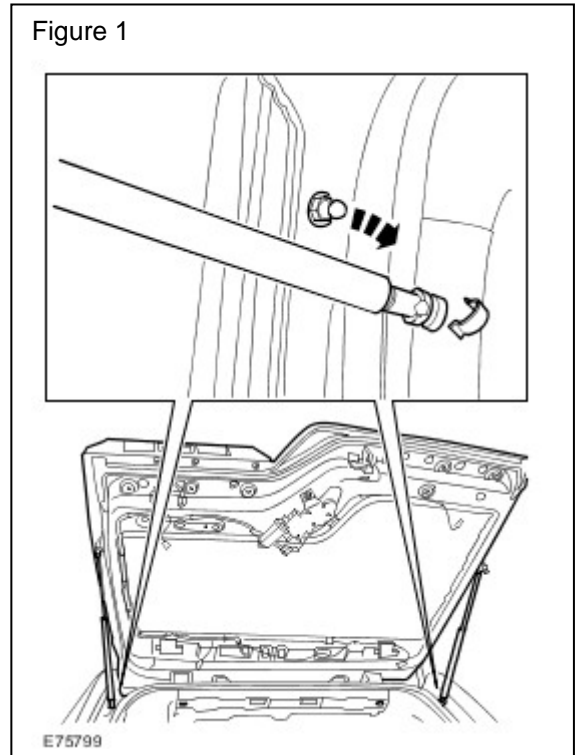
Figure 1

Cause: Torque relaxation of the upper strut support ball fitting, which could develop into damage to the mounting, may be the cause.

1. Remove the upper tailgate support strut from the D-pillar ball fitting. (Figure 1)
2. Disassemble the ball fitting, checking for damage to both the ball fitting and the securing nut thread.
3. If no damage is detected, complete repairs as follows:
 - Apply liquid thread lock (STC50552) to the thread of the ball fitting.
 - Install the ball fitting.
 - Tighten to **23 Nm (17 lbf-ft)**.
 - Install the upper tailgate support strut.
 - Verify proper operation of the tailgate and no rattle is present while driving.
4. If securing nut thread is damaged, or the nut has been displaced into the D-pillar, perform tailgate support repair.
