TECHNICAL BULLETIN

No: LA-501-018
Issue: 1
Date: 25 Apr 2006

Safety Belt Pretensioner Wire Routing

Land Rover LR3 (LA)

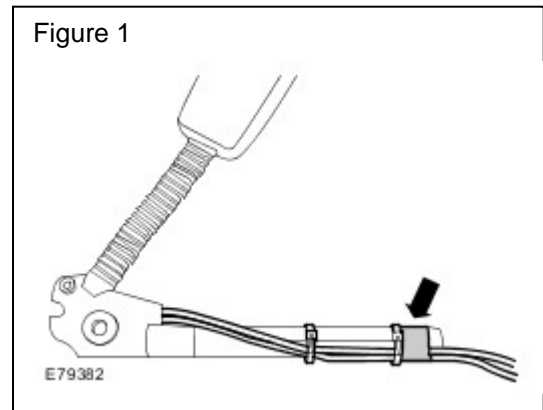
Figure 1

Situation: If not properly routed and secured the wiring of a replacement safety belt pretensioner can become trapped in the seat track. Prior to installing a new pretensioner, the wiring **must** be properly routed and secured to prevent potential damage to the wiring.

CAUTION: Care must be taken to avoid damage to the pretensioner wires. The wires must face away from the inboard side of the seat when secured by the cable ties. The cable ties must not be over-tightened.

1. Align the new safety belt pretensioner assembly to the existing front seat pretensioner that is to be replaced.
2. Route the wiring of the new pretensioner along the side of the pretensioner tube so that the wiring is facing away from the inboard side of the seat. (Figure 1)
3. Secure the wiring in two positions with the cable ties, ensuring not to over-tighten the cable ties. (Figure 1)
4. Using black fabric tape, secure the wiring to the pretensioner tube, ensuring the tape does not extend beyond the end of the tube. (Figure 1)
