# TECHNICAL BULLETIN

No: LTB00097  
Issue: 3  
Date: 05 MAY 2008

## Steering Column Knock – Repair Procedure

**MINOR 'KNOCKING' NOISE FROM THE STEERING INTERMEDIATE SHAFT**

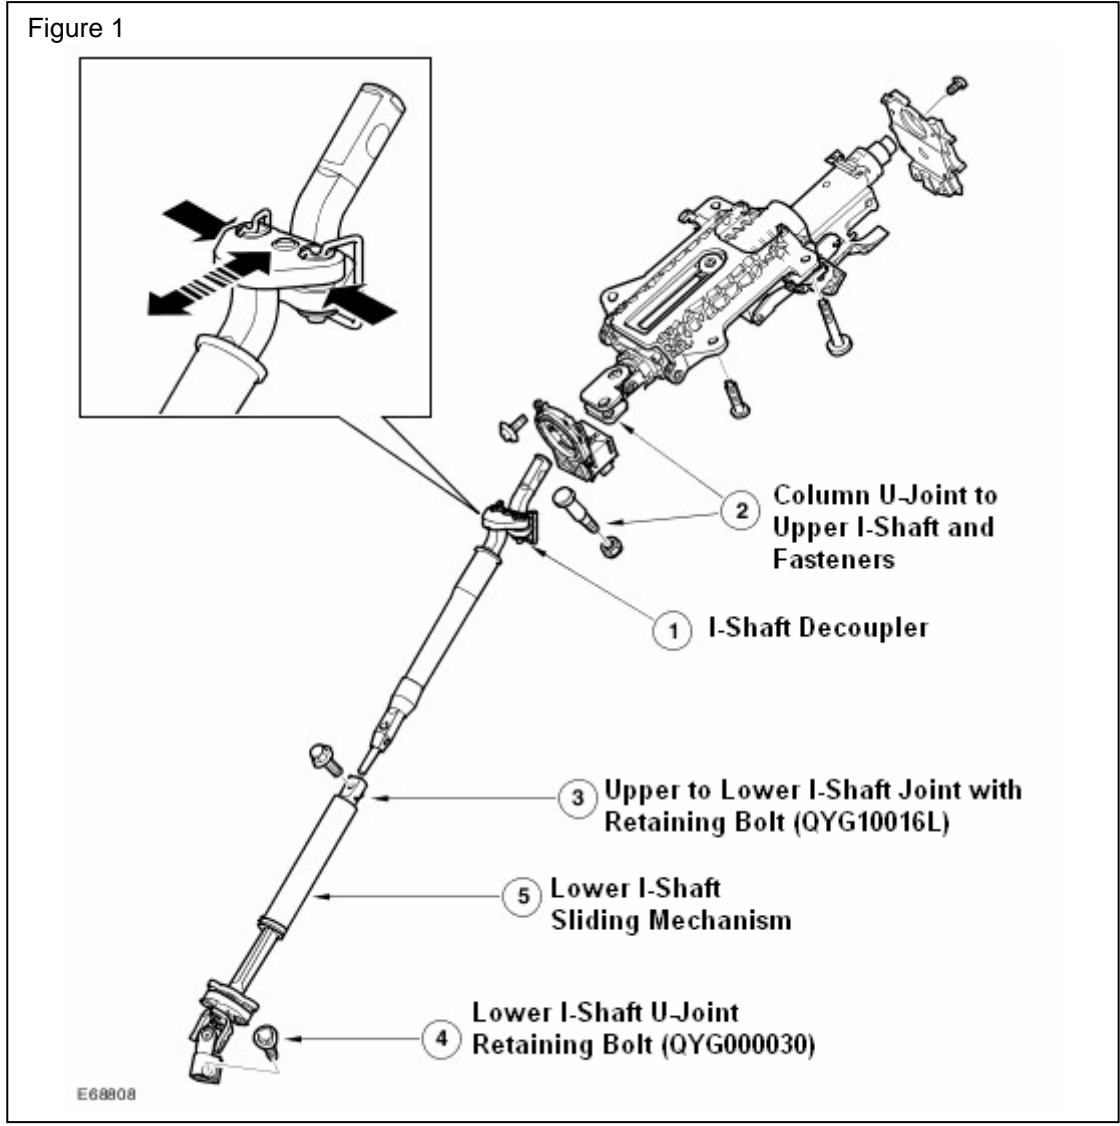
## LR3 STEERING COLUMN AND I-SHAFT ASSEMBLY

**Situation:** A customer may report a concern of a minor 'knocking' noise coming from the front of the vehicle or a steering system component while driving over small bumps or undulating road surfaces. A low resistance in the sliding mechanism of the lower steering shaft may be the cause of the noise.

1. Inspect the upper and lower intermediate shaft assembly as follows:
  - Inspect the upper intermediate shaft 'decoupler' assembly for excessive movement. (Arrowed in Figure 1 inset)
  - Inspect the upper intermediate shaft decoupler assembly and ensure the steel and rubber washers are correctly located. (Inset in Figure 1)
  - Verify that the fasteners joining the steering column universal joint to the upper intermediate shaft are tightened to **22Nm (16lbf-ft)**. (2 in Figure 1)
  - Inspect the joint between the upper intermediate shaft and lower intermediate shaft for any movement. (3 in Figure 1)
  - Inspect the joint between the lower intermediate shaft universal joint and steering gear for any movement. (4 in Figure 1)
  - Inspect the sliding mechanism of the lower intermediate shaft for any lateral 'play' or looseness. (5 in Figure 1)

2. If movement is discovered as quantified below, repair in sequence and as instructed:
  - If excessive movement exists in the upper intermediate shaft 'decoupler' assembly, replace the upper intermediate shaft (QLB500070).

- If any of the decoupler assembly washers is incorrectly located, replace the upper intermediate shaft (QLB500070).
  - If any movement exists in the connection between the upper intermediate shaft and lower intermediate shaft, replace the retaining bolt (QYG10016L) and tighten to **30Nm (22lbf-ft)**. (3 in Figure 1)

- If any movement exists in the connection between the lower intermediate shaft universal joint and steering gear, replace the retaining bolt (QYG000030) and tighten to **30Nm (22lbf-ft)**. (4 in Figure 1)

- If any lateral 'play' or looseness exists in the sliding mechanism of the lower intermediate shaft, replace the lower intermediate shaft (QMN500250).
