TECHNICAL BULLETIN

No: LTB00296 (ISSUE 1)
18 FEB 2011

RANGE ROVER

Upper Glove Compartment Rattle

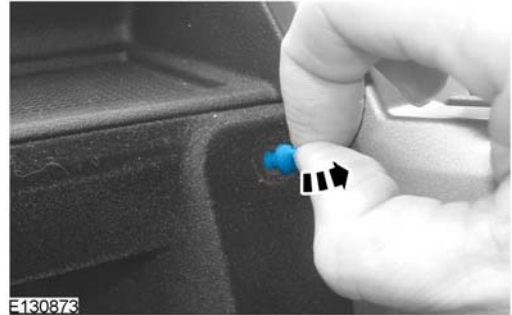
Figure 1

Situation: The upper glove compartment may exhibit a rattle. This may be caused by the upper glove compartment lid bump stop(s) being worn.

1. Open the upper glove compartment lid
2. Remove the existing right-hand (RH) bump stop from the compartment liner. (Figure 1)
