# TECHNICAL BULLETIN

No: LA-204-001  
Issue: 1  
Date: 02 May 2005

## Air Suspension Connector Water Ingress

Land Rover LR3 (LA)

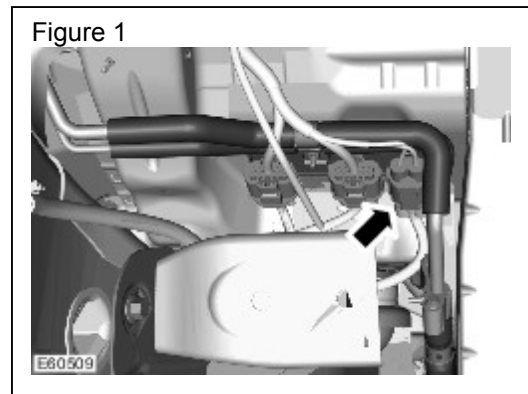
4. Refer to GTR section 76.10.48 and release the rear lower edge of the LH fender splash shield.
5. Position the fender splash shield aside in order to gain access to the electrical connectors.
6. On vehicles fitted with rear air conditioning, release the 'P' clip securing the air conditioning pipe to allow access to the connector. (Figure 1 shows correct routing of the wiring harnesses in front of the air conditioning pipes.)

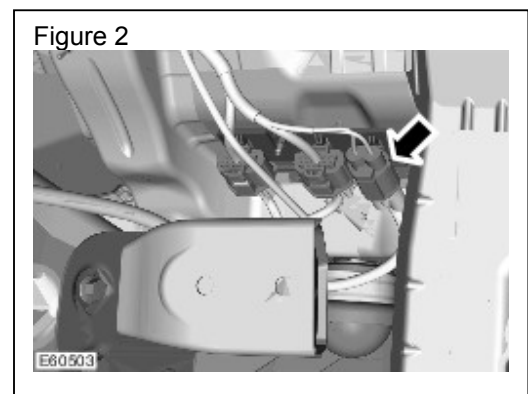
7. Locate and remove from its mounting bracket the blue connector C2527/C2528 at the rear of the wheel arch. (Figure 2)
8. Cut the electrical wires as close as possible to the connectors and discard the old connector.
9. Reposition the wire identifiers if installed.
