# TECHNICAL BULLETIN

No: LA-414-001  
Issue: 1  
Date: 11 Jan 2006

## Battery Junction Box Connections

Land Rover LR3 (LA)                      VIN: ALL

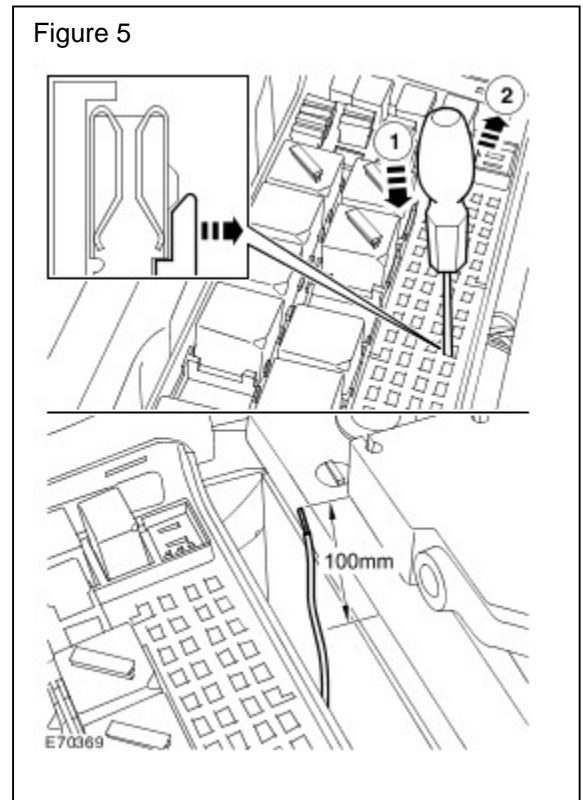
Figure 5

10. If the fuse terminal is damaged or the fuse is not held securely when inserted, replace the damaged terminal as follows:

- Using special tool YRW500030 from the harness repair kit, release the damaged terminal from the aperture by disengaging the terminal securing tang and pulling the wire/terminal from the underside of the fuse box. (Figure 5)
- Cut the terminal wire approximately 100mm (4 inches) from the terminal. (Figure 5)
- Place a piece of heat-shrink wiring insulation over the cut wire and move aside.
- Using the new terminals supplied with the repair kit (YPL900310 - 2.5mm blue wire – SPX Reference 418-587-14), splice the new terminal wire to the cut wire.
- Position the heat shrink insulation over the wiring joint and apply heat to shrink the insulation.
