# TECHNICAL BULLETIN

No: LTB00084  
Issue: 1  
Date: 5 Oct 2007

## Glass Roof Panel Blind Difficult to Latch – Repair Procedure

LR3 (LA)

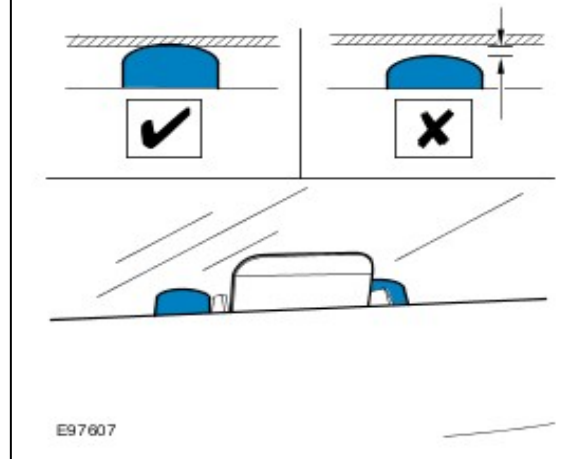
Figure 1

1. Open the second row glass roof panel blind.
  - Visually inspect the rubber spacers between the headliner and the glass of the second row (✓ in Figure 1) to verify the spacer is touching the glass.

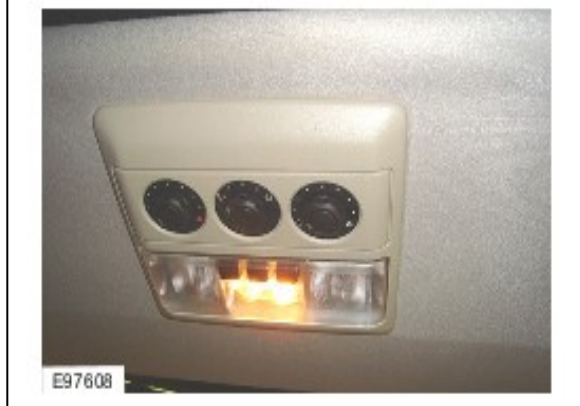
Figure 2

2. Verify the dome lamp is installed correctly with no gaps between lamp and headliner. (Figure 2)
3. If the lamp is not fully clipped into the roof, apply pressure as indicated by the arrow. (Figure 3)
4. Verify the two white clips at the front and rear of the roof opening panel headliner are fully clipped into the body. (Figure 4)
5. If clips are not fully installed, apply pressure in direction of arrow. (Figure 4)
6. Carry out steps 4 and 5 of the inspection process on the third row/rear loadspace blind.

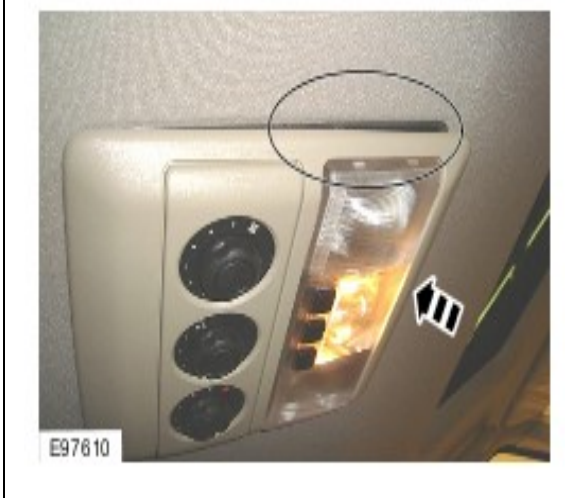
Figure 3

**NOTE: Gapping will show when the dome lamp has not been installed correctly. (Figure 3)**
