Work Order: Last Name: R000025 SN06 KYR

Land Rover: Discovery: 2005-09 (Series III): with Dynamic Air Suspension: Right-hand Drive

Before Measurements

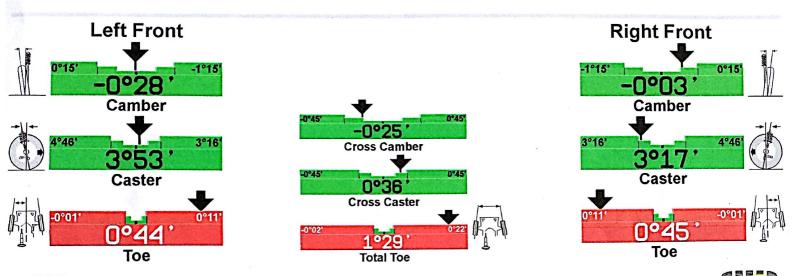
Excessive Thrust Angle could cause a crooked steering wheel.

This vehicle's Steering Angle Sensor may require calibration using an OEM scan tool after alignment.
