# TECHNICAL BULLETIN

No: LTB00191  
Issue: 1  
Date: 20 MAY 2010

## Liftgate Latch Diagnostics

LR3 (LA)

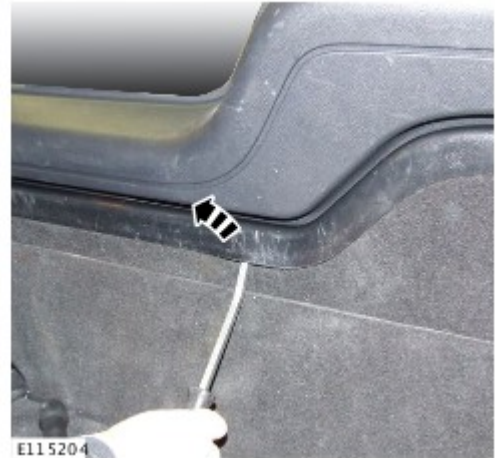
Figure 1

1. Remove the lower tailgate trim:
  - Carefully pry the lower tailgate carpet from under the top of the lower liftgate. (Figure 1)

1. Remove the lower tailgate trim:
  - Carefully pry the lower tailgate carpet from under the top of the lower liftgate. (Figure 1)
2. Access the liftgate latch:
  - Pull the carpet trim away from the lower liftgate. (Figure 2)
3. Cut the water shedder to access the latch.
  - Insert a small screwdriver through the hole in the water shedder and release the latch. (Figure 3)

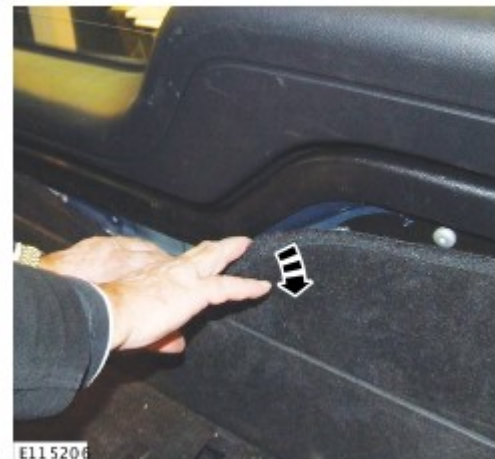
Figure 2

2. Access the liftgate latch:
  - Pull the carpet trim away from the lower liftgate. (Figure 2)

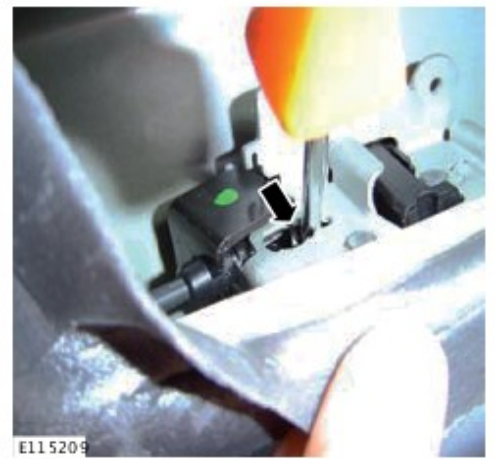
Figure 3

4. Insert a small screwdriver through the hole in the water shedder and release the latch. (Figure 3)

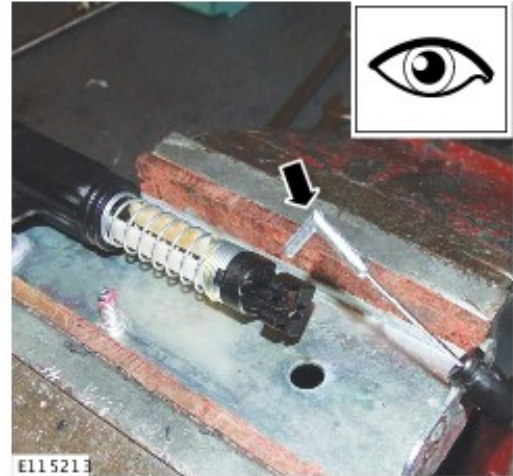
Figure 4

- If the cable end is detached from the actuator, (Figure 4) install the cable end to the actuator; use a suitable cable tie to secure cable end to actuator. (Figure 5)

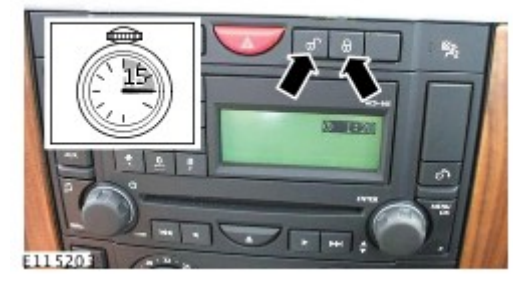
Figure 6

1. Manually override the liftgate by holding the 'lock' and 'unlock' buttons on the fascia switchpack for 15 seconds. (Figure 6)
  - If the liftgate latch releases but the external release button does not function, replace the exterior handle assembly.
  - If the liftgate latch fails to release using the manual override, refer to ACTUATOR MANUAL OVERRIDE DOES NOT FUNCTION; LATCH DOES NOT OPEN below.

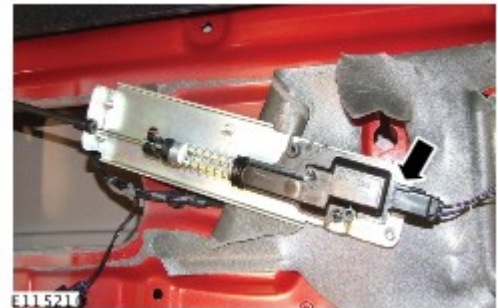
Figure 7

4. Refer to Workshop Manual (GTR) sections 501-14, *Liftgate Latch* (76.37.19) *Liftgate Latch Actuator* (86.26.27) and remove the latch and actuator. (Figure 7)
5. Connect the electrical connector to the actuator.
6. Press the external release button and check for actuator / latch movement.
7. If the actuator does not function, refer to ACTUATOR FAILS TO RESPOND below.
