TECHNICAL BULLETIN

LTB00563v3

Smart Key Low Level Repair

Situation: The face of the key is peeling away from the main body. This version has been issued for a change to the Service Instructions and the SRO time.

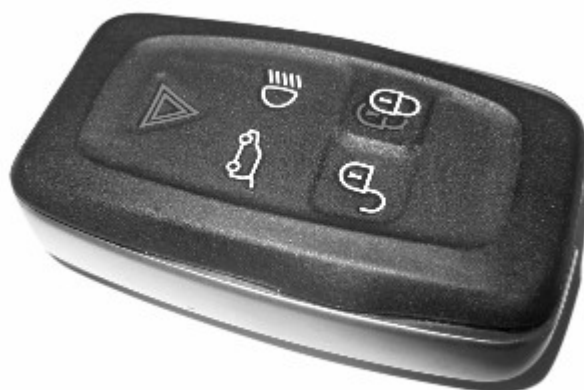
E158175

1.

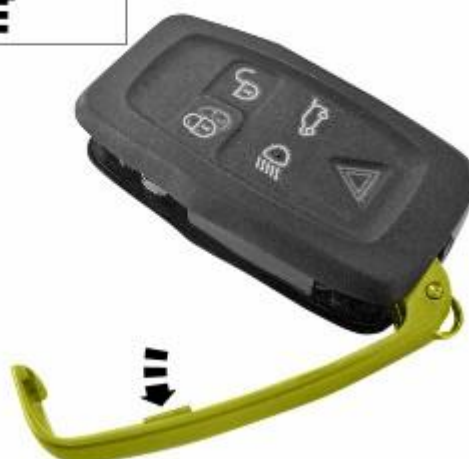
E158176

2. Release Button pull the Battery Cover Frame Open.

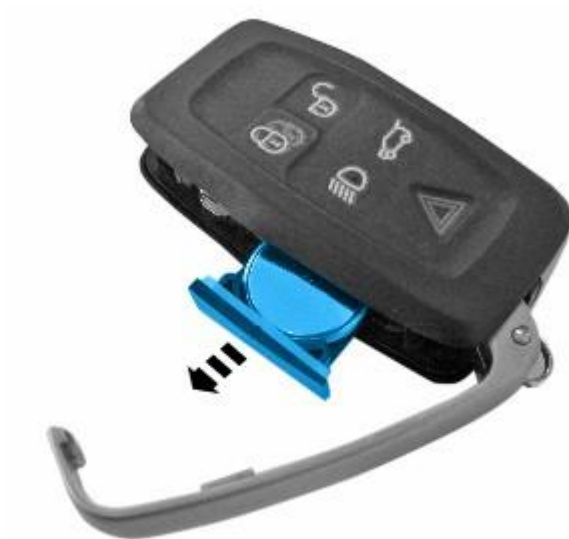
E158177

3. Remove the battery holder assembly and place to one side.

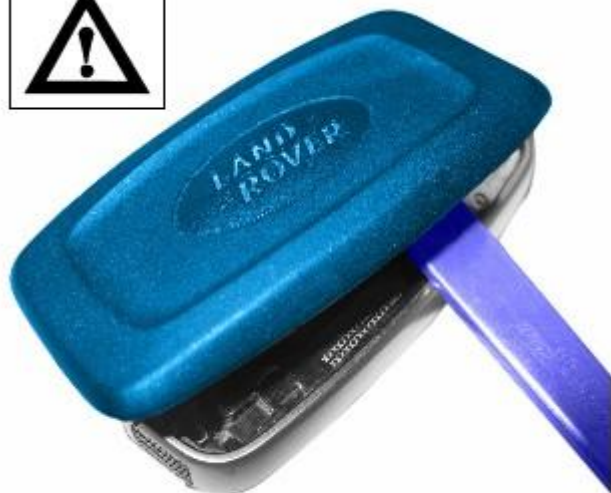
E158178

4. Using a suitable tool lever open the body of the smart key.

1. Discard the upper-case.

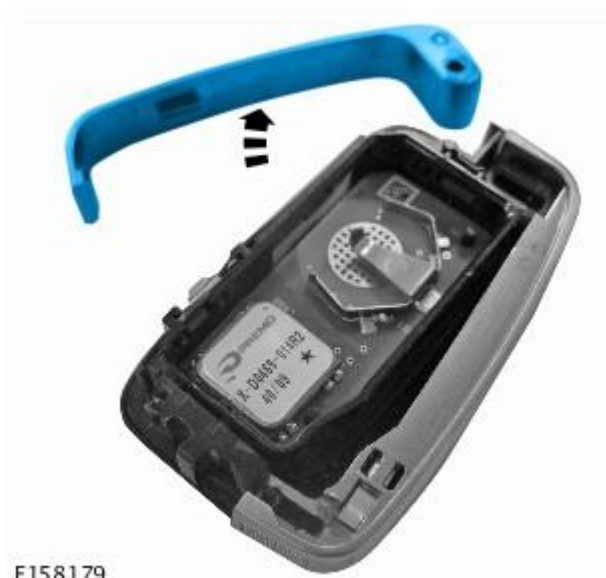
E158179

5. Remove and place to one side the battery cover frame.

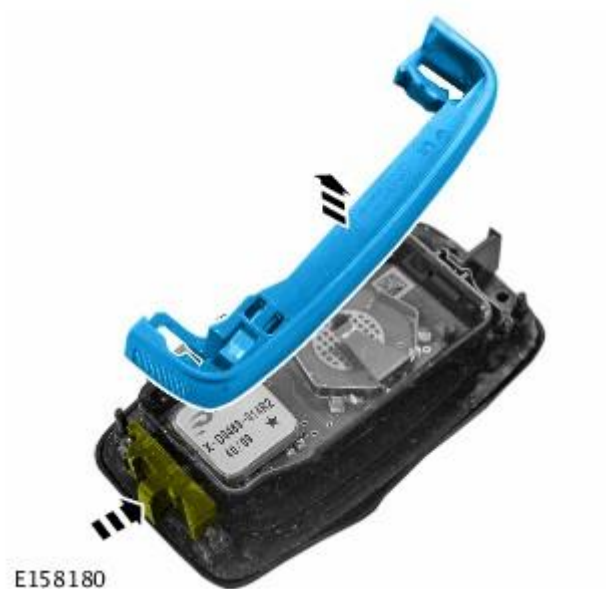
E158180

6. Remove and place to one side the key frame holder.

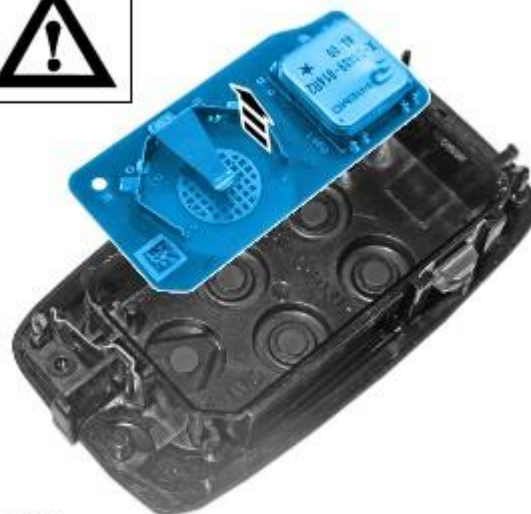
E158181

**CAUTION:** On removing the Printed Circuit Board (PCB) only handle on the outer edges of the board.

**NOTE:** Remove the PCB place to one side.

Remove the PCB.

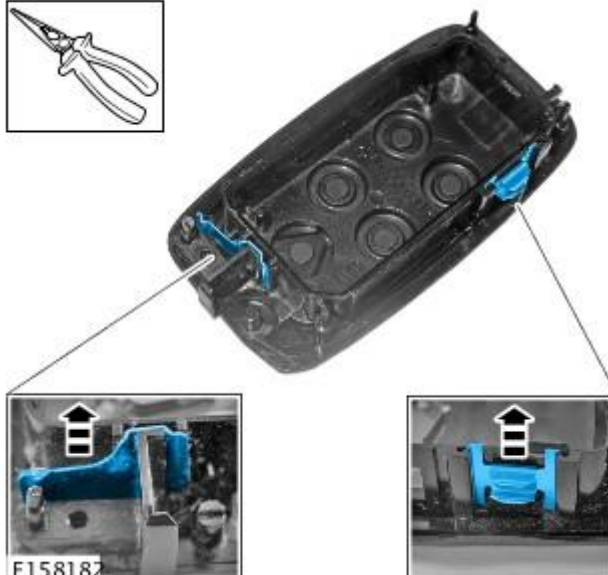
E158182

8. Remove retaining clip and leaf spring and place to one side.

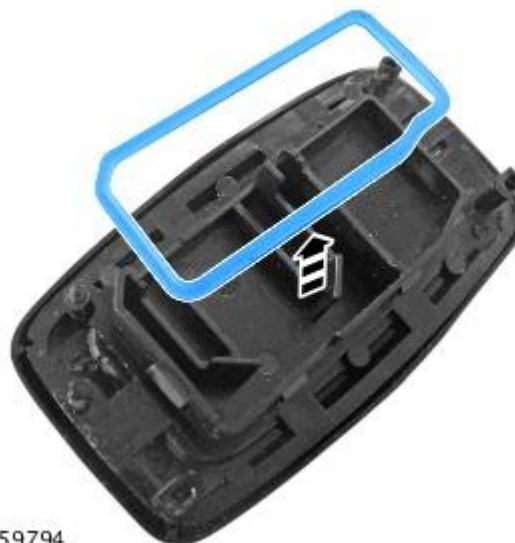
E159794

9. Remove the silicon seal from old lower case.

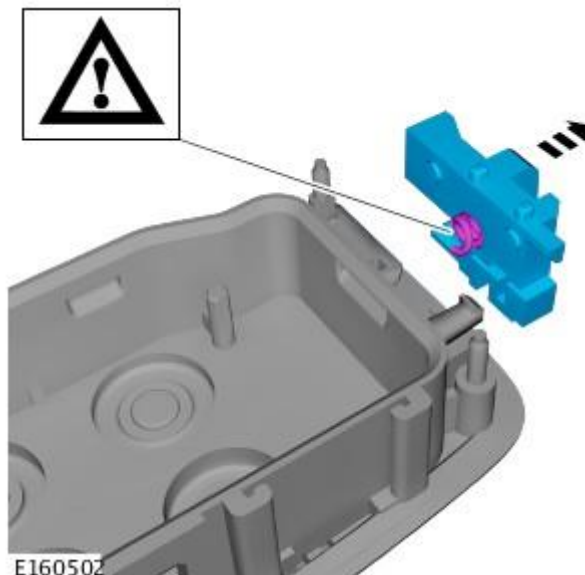
E160502

**NOTE: Make sure the spring is retained as it is required on the install procedure.**

Remove the Release Button, discard the lower-case.

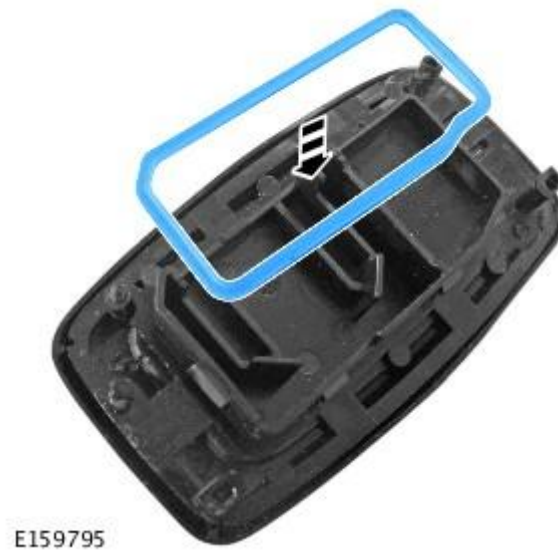
12. Install the silicon seal.

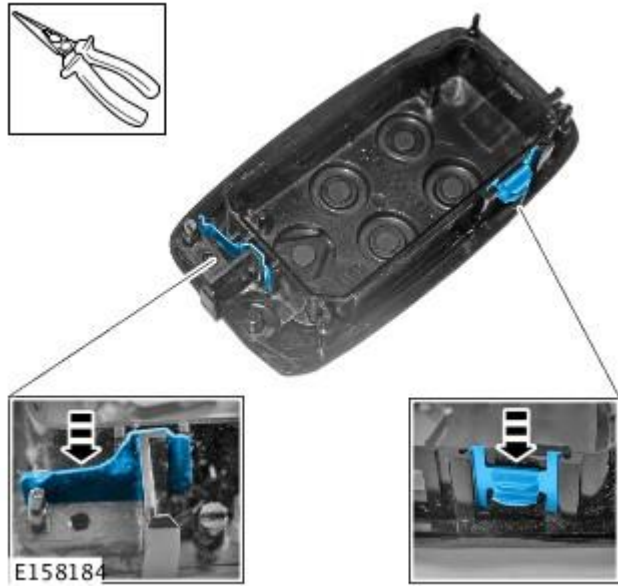
13. Install the retaining clip and leaf spring as E158184.

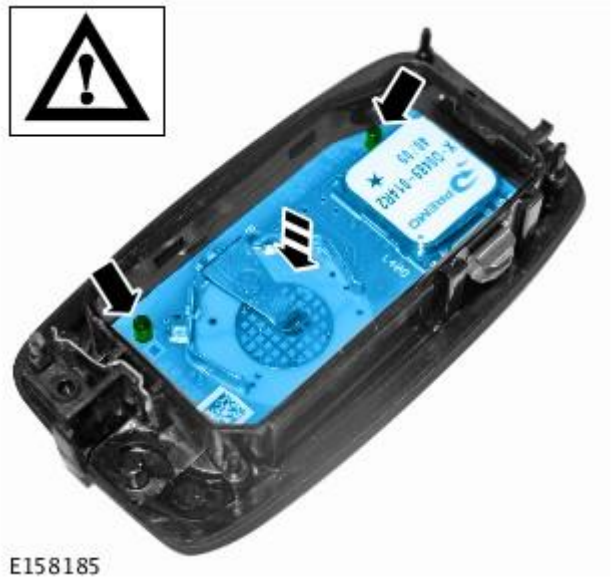
**CAUTION:** On installing the Printed Circuit Board (PCB) only handle on the outer edges of the board.

Install the PCB.

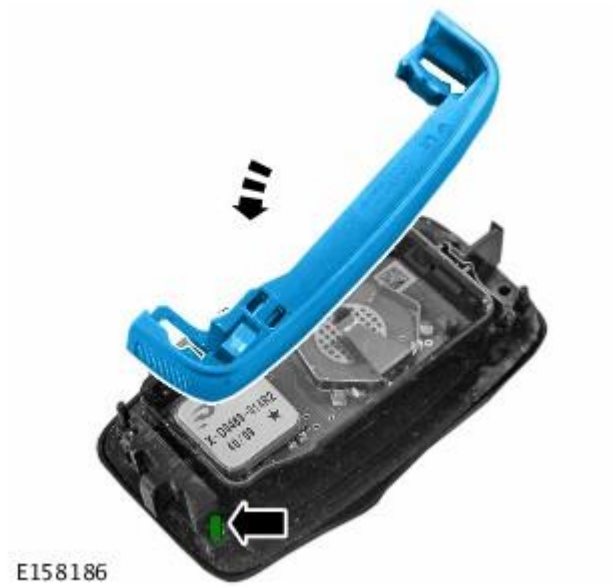
15. Install the key frame holder.

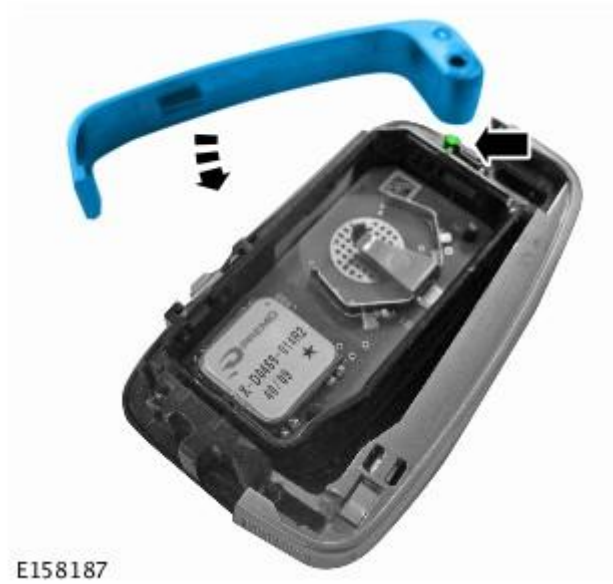
16. Install the battery cover frame.

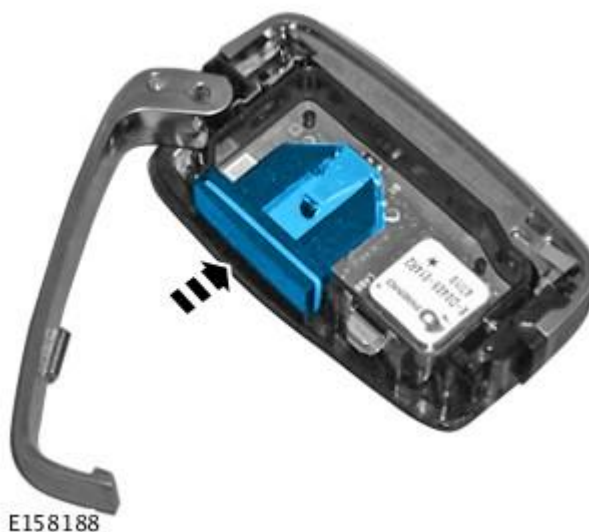
17. Install the battery holder assembly.

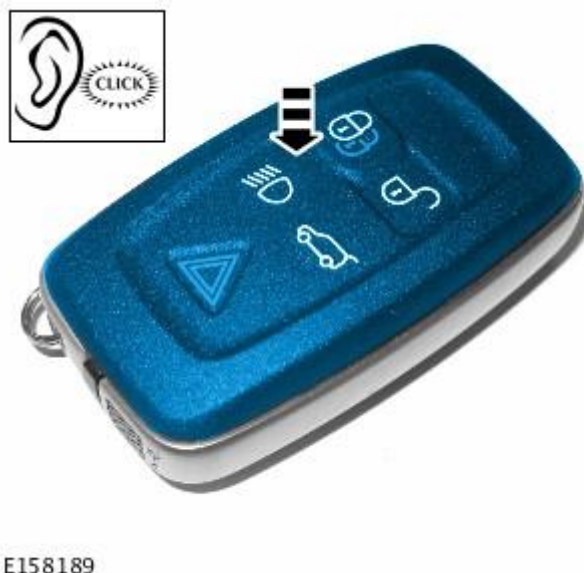
18. Press the two half's of the smart key together, listen for a audible click to make sure they are correctly assembled.
