Connector: **C0391**

Description: **Chassis harness to main harness**

Location: **Below LH rear wheelarch**

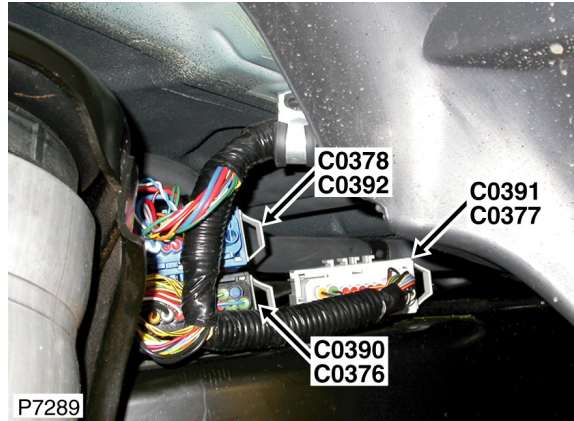
Part No.: **YPC909640**

Colour: **LIGHT GREY**

Cavities: **18WY**

Harness: **CHASSIS HARNESS**

CAV	CSA	COL	CCT	DESTN	Pre-Terminated Lead	Extract Tool	Applicator	Wire Stripper	Heat Shrink Sleeve	Ident Sleeve	Splice
1	1.0D	BY	419	C2101	-	-	-	-	-	-	-
2	1.0D	BG	419	C2101	-	-	-	-	-	-	-
7	1.0D	BW	419	C2101	-	-	-	-	-	-	-
8	1.0D	BU	419	C2101	-	-	-	-	-	-	-
9	1.0D	BP	419	C2101	-	-	-	-	-	-	-
10	1.0D	BO	419	C2101	-	-	-	-	-	-	-
11	0.5D	BO	419	C0781	418-411-73	-	418-116A	418-117	418-104	418-112	418-107
12	0.5D	OY	419	C1699	418-411-09	-	418-116A	418-117	418-104	418-112	418-107
13	0.5D	OR	419	C1699	418-411-09	-	418-116A	418-117	418-104	418-112	418-107
14	0.5D	OB	419	C1699	418-411-09	-	418-116A	418-117	418-104	418-112	418-107
15	0.5D	SY	419	C1698	418-411-09	-	418-116A	418-117	418-104	418-112	418-107
16	0.5D	SU	419	C1698	418-411-09	-	418-116A	418-117	418-104	418-112	418-107
17	0.5D	SR	419	C1698	418-411-73	-	418-116A	418-117	418-104	418-112	418-107
18	0.5D	BN	419	C0781	418-411-73	-	418-116A	418-117	418-104	418-112	418-107
