Connector: **C1699**

Description: **Sensor-Height-Rear-LH**

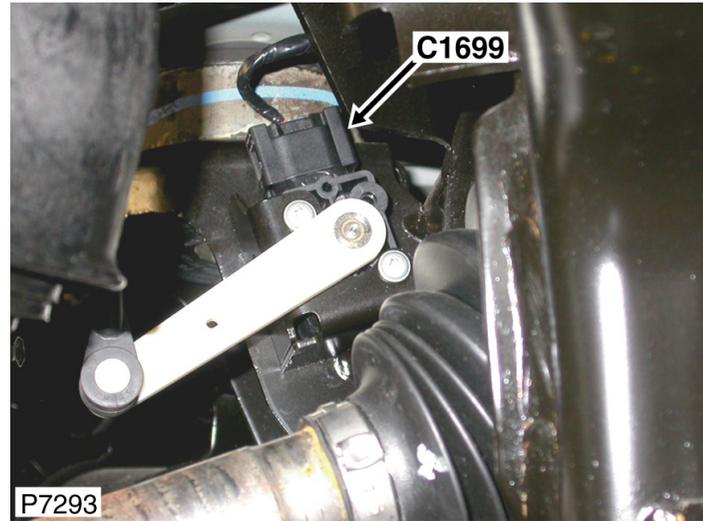
CONNECTOR HOUSING NOT SERVICEABLE

Cavities: **3WY**

Location: **Below LH rear wheelarch**

CAV	CSA	COL	CCT	DESTN	Pre-Terminated Lead	Extract Tool	Applicator	Wire Stripper	Heat Shrink Sleeve	Ident Sleeve	Splice
1	0.5D	OY	419	C0391	418-549-11	-	418-116A	418-117	418-104	418-112	418-107
4	0.5D	OR	419	C0391	418-549-11	-	418-116A	418-117	418-104	418-112	418-107
5	0.5D	OB	419	C0391	418-549-11	-	418-116A	418-117	418-104	418-112	418-107
